Inspection Report Minerals Regulatory Program

Mine Name: Green River Project	Permit number: S/019/058			
Operator Name: Green River Project, LLC	Insp 2005	ection Date:	August 17,	
Inspector(s): Paul Baker Other Participants: None Mine Status: Active	Time: 2:00-2:30 PM Weather: Partly cloudy, 90's			
Elements of Inspection	Evaluated	Comment	Enforcement	
 Permits, Revisions, Transfer, Bonds Public Safety (shafts, adits, trash, signs, highwalls) Protection of Drainages / Erosion Control Deleterious Material Roads (maintenance, surfacing, dust control, safety) Concurrent Reclamation Backfilling/Grading (trenches, pits, roads, highwalls, shafts, drill holes) Water Impoundments Soils Revegetation Air Quality Other Purpose of Inspection:

Photographs
S/019/058, Green River Mine, Green River Project, LLC
Inspection Dated: August 17, 2005; Report Dated: September 7, 2005

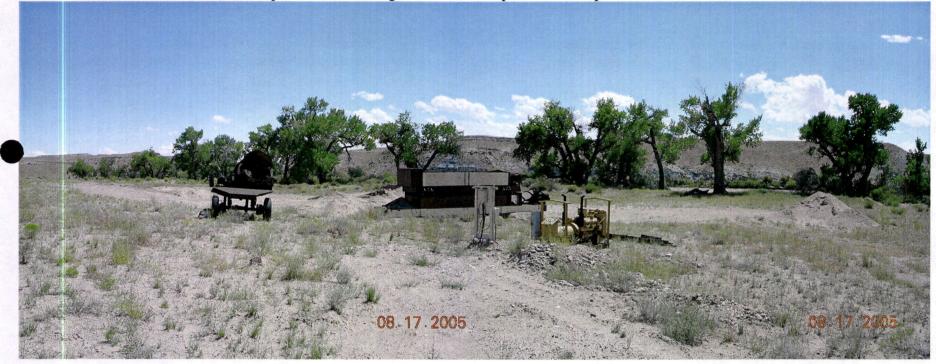
Equipment on site includes a diesel tank, a generator, a grizzly, and a tubular fine particle screen (Photo 1). There had previously been a blue screen in an adjacent area, but it was gone.

Photo 1. The new disturbance with equipment.

The operator needs to be sure to salvage and protect topsoil.

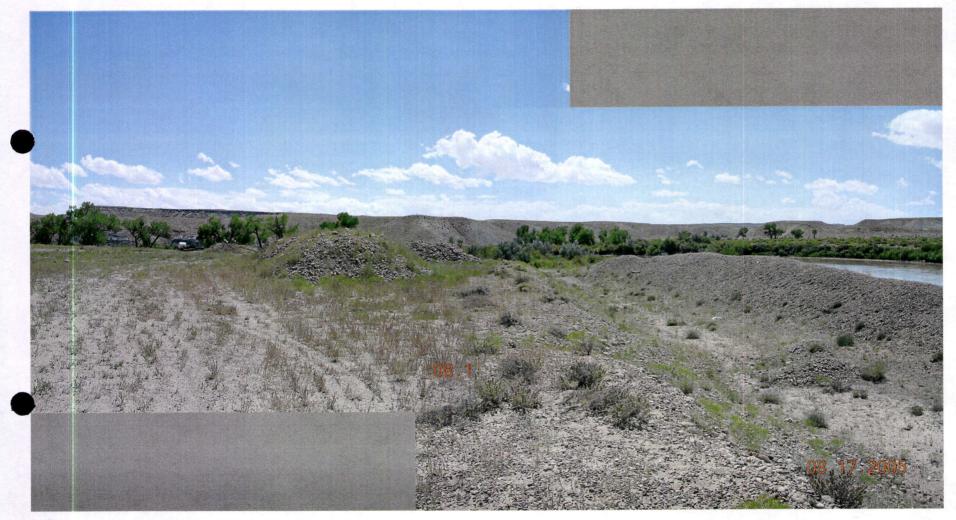
The operator has begun operations in a 0.53-acre area just south of the area shown on the map in the Notice of Intention to Commence Small Mining Operations. I used a GPS unit to map this area and a nearby area that was previously disturbed by mining (Photo 2). The previously disturbed area (3.08 acres) overlaps into the permitted area.

Photo 2. A previously disturbed area along the Green River.

The operator needs to affirm he has right of entry for the area that has been disturbed or needs to obtain that right of entry. Additionally, the map in the plan needs to be revised to include the disturbed area.

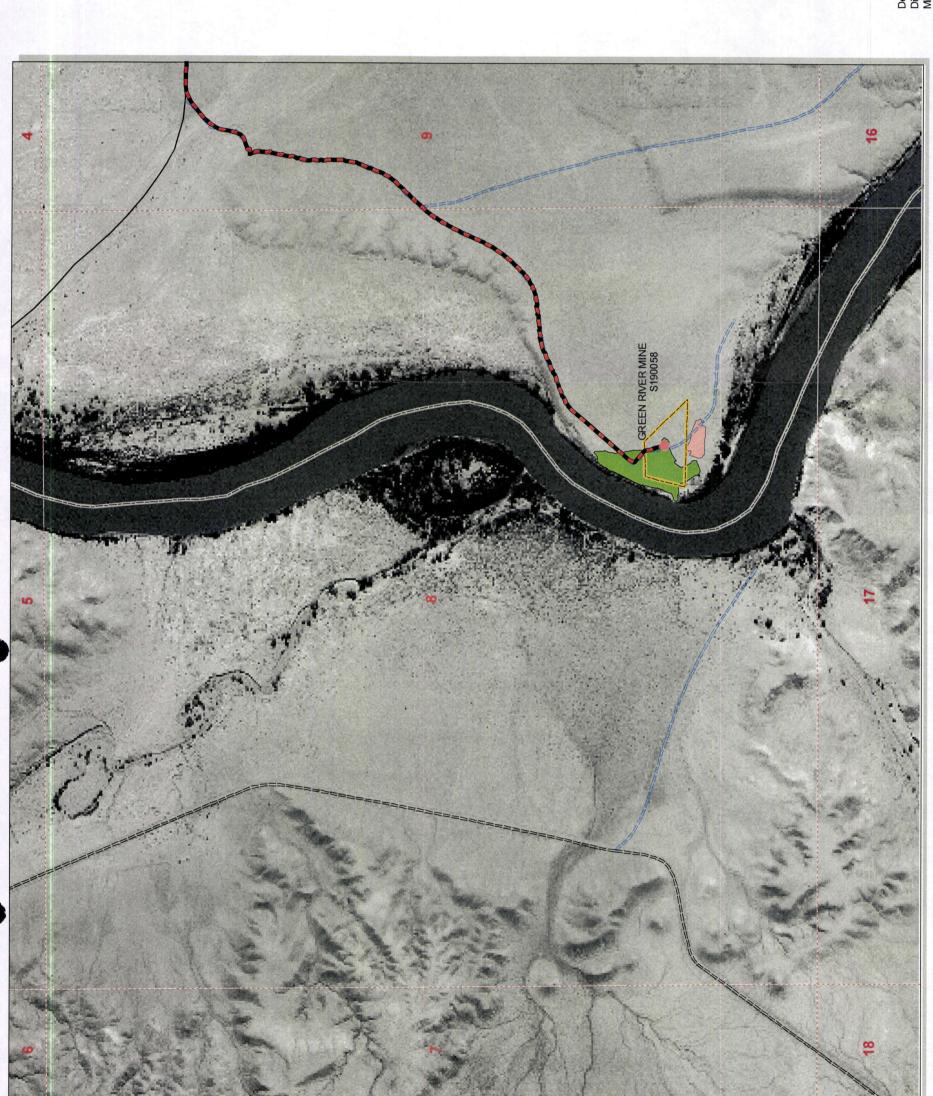
Mine Name: Green River Mine Township 22 S Range 16 E Mine Number: S190058 Section 08 SLBM

0.53	0	0	0	0.53	0	3.08	0
Acres Disturbed	Acres Regraded	Acres Seeded	Road Acres Disturbed	Total Acres Distrubed	Acres Redaimed	Acres Excluded	Acres Prelaw
